Pre ABRP Hatch (Oct 2017)

Bells & Clock Preparation

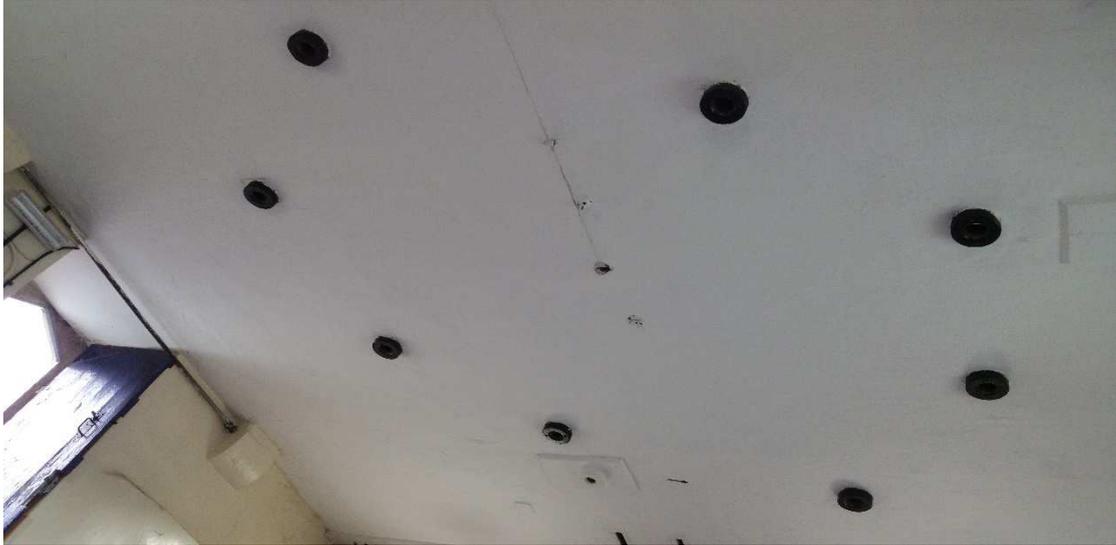
Existing ceiling showing circle of rope bosses for 8 bells

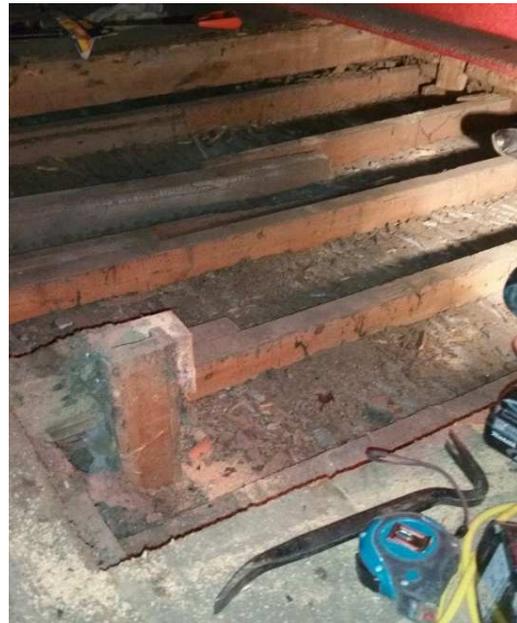
Floorboards lifted and floor joists removed in belfry to reveal ceiling joists. Note 5th rope vertical chute

The clock was stopped and switched off at 08am. The access tower was erected in the centre of the ringing room. All of the boards in the belfry were lifted and floor joists removed to reveal the space required to fit the hatch. The remaining cut timbers were treated and the ceiling marked out for cutting.

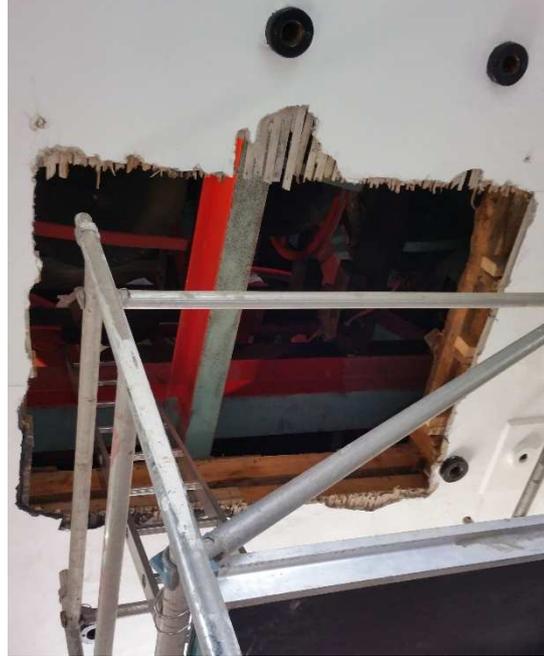
Lath & plaster ceiling cut through & removed

Tarpaulin fitted under the ceiling to catch cut section to be removed. Ceiling joists cut through and removed. Lath & plaster ceiling cut through and removed. Redundant materials bagged up and carted away.

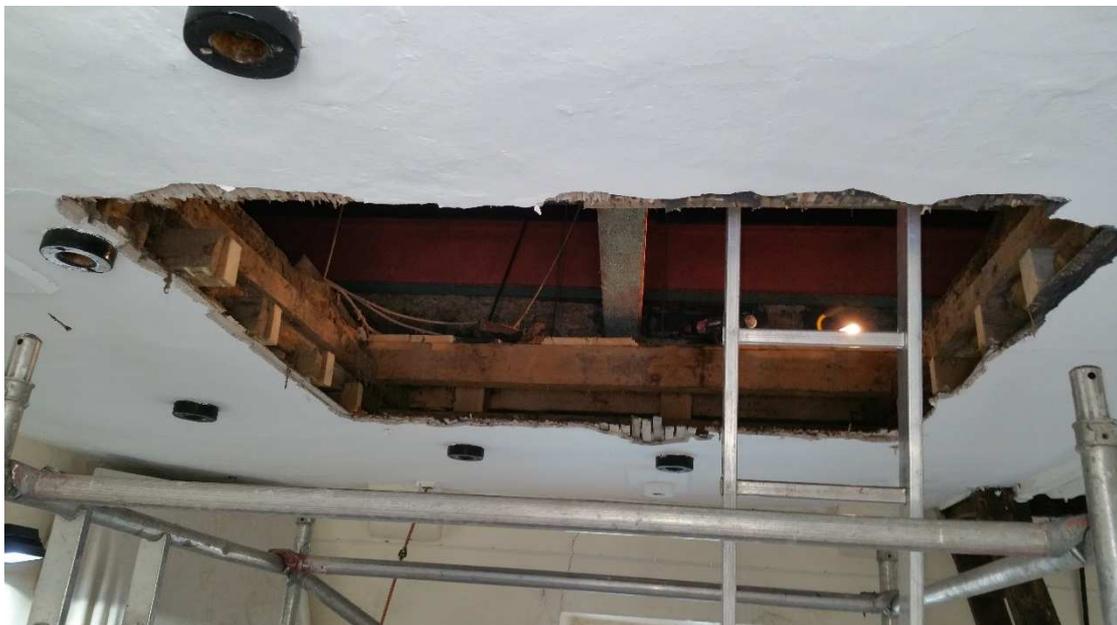
Ceiling joists cut back in line with hole cut out

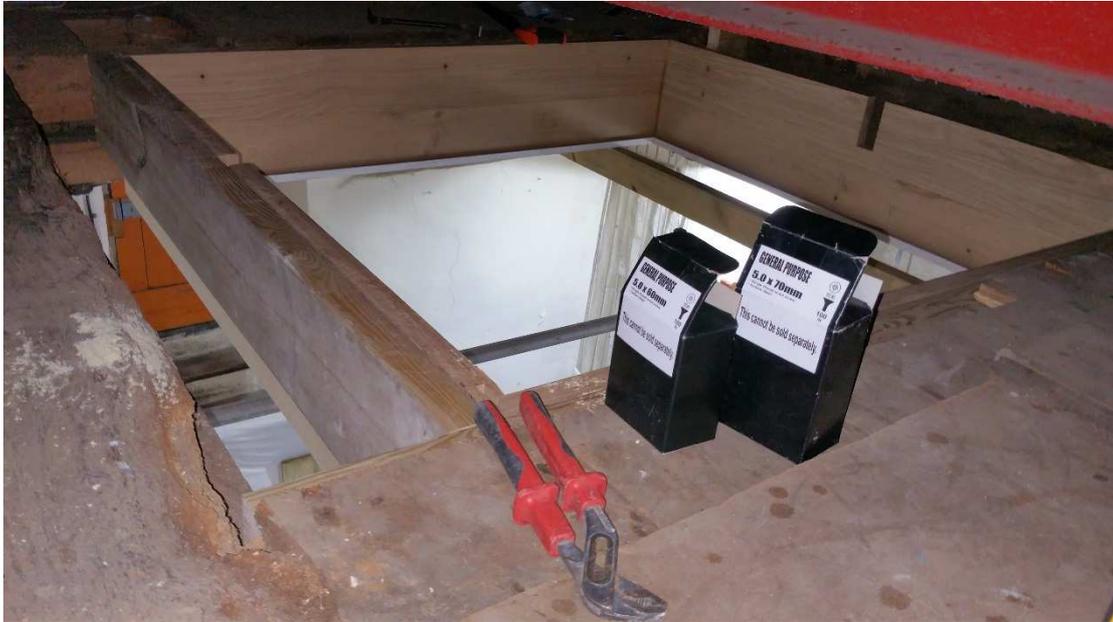
Oak hatch frame in position as seen from above

The solid oak hatch frame had to be raised piece by piece into the belfry then assembled and trimmed to fit existing floor/ceiling depth had to be trimmed to match. The hatch pieces were glued and screwed together, lifted into position and secured to new and existing trimmers/joists.

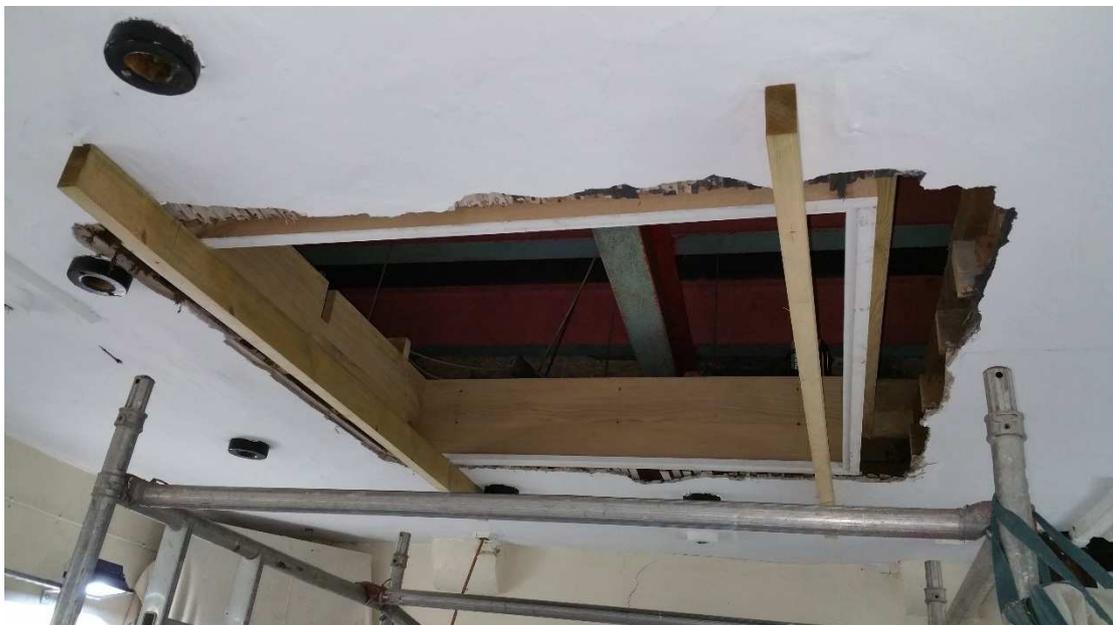
Oak hatch held in place by temporary joists as seen from below

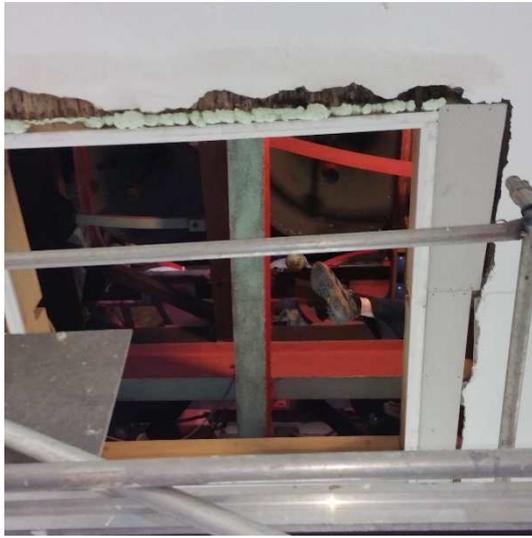
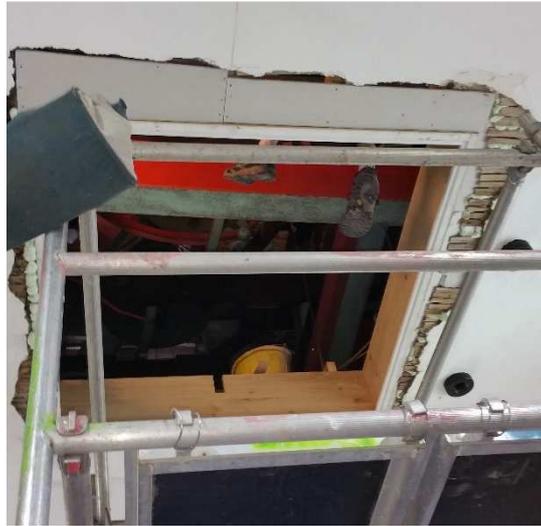
Gaps filled

Ceiling gaps were filled. New joists cut and fitted. Rope boss hole in ceiling cut. Rough plastered.

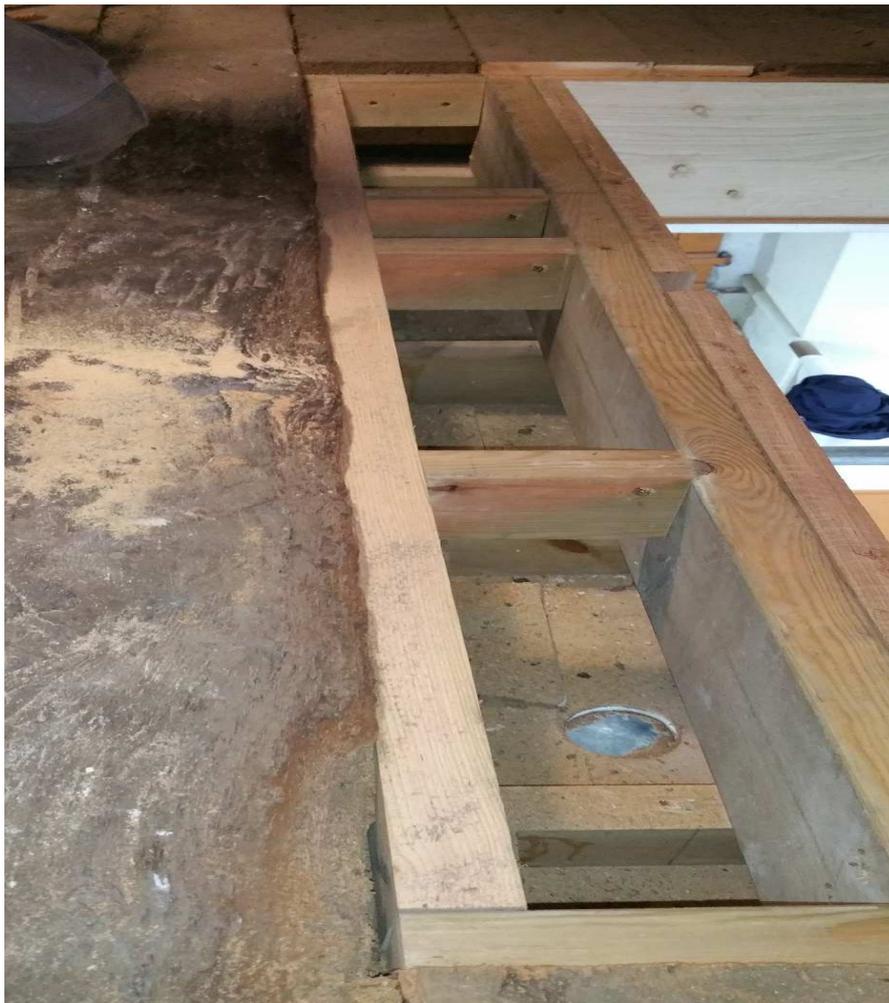
New joists cut and fitted. Ceiling rope boss hole cut.

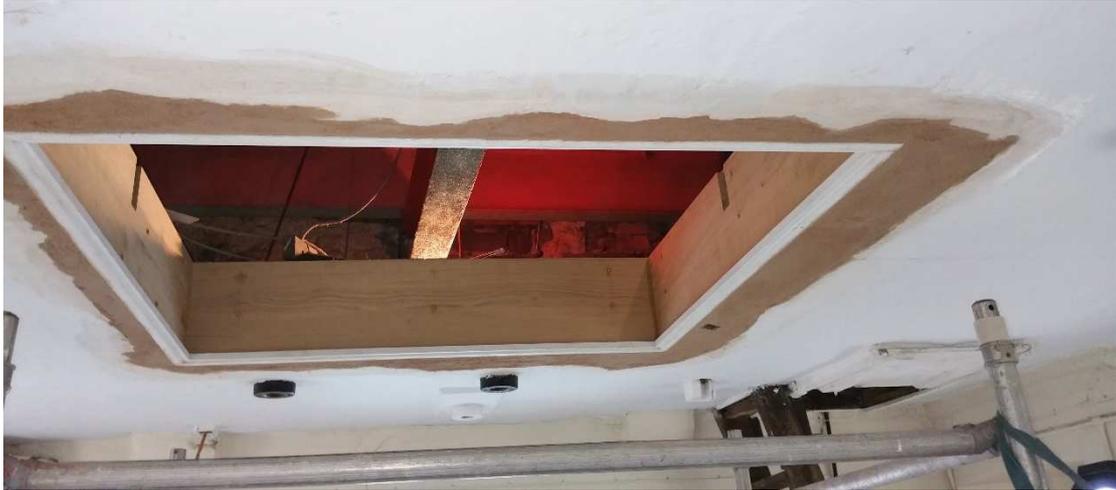
Architrave fitted and plaster finishing coat applied

Finishing coat of plaster applied to the ceiling then allowed to dry before painting. Architrave fixed in place and new rope ceiling boss for the 5th also. Fixed lifting rings to ceiling and floor panels. Final plaster coating applied. Existing floor boards cut to size and reused. Hole for new floor boss for the 5th cut and fitted. New plaster left overnight to dry out. Lots of clearing up before painting tomorrow.

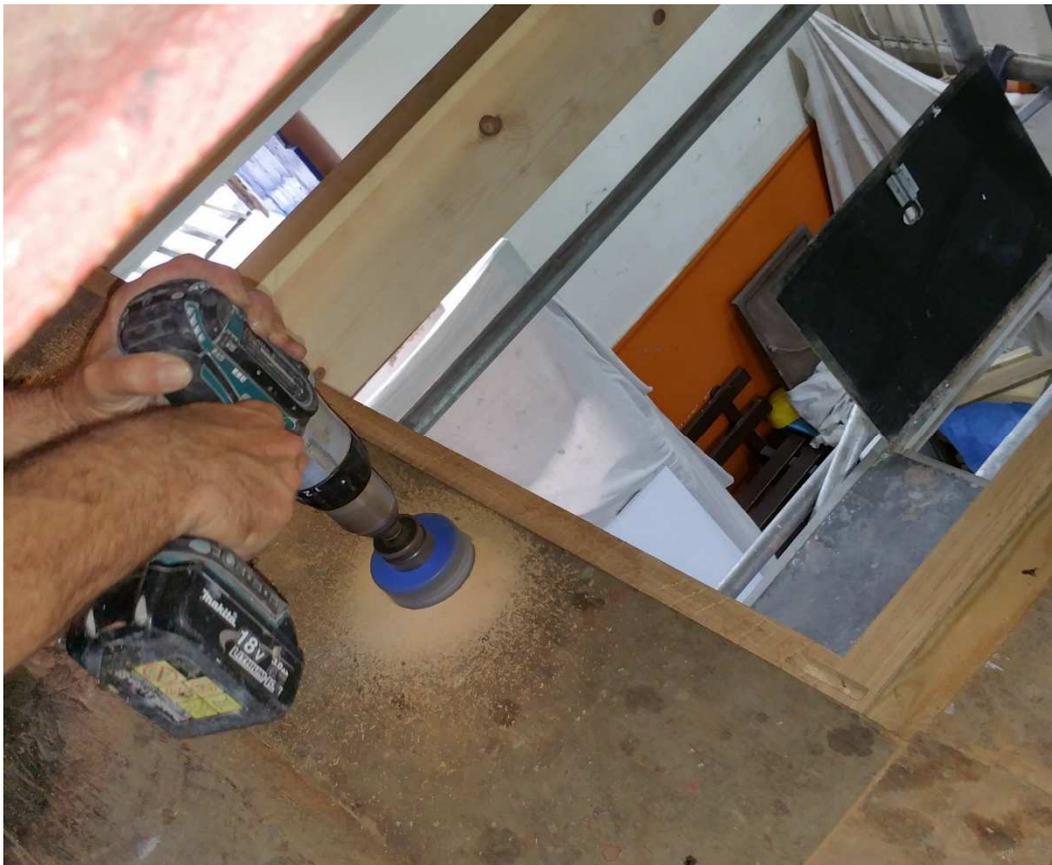
New floor boss hole for 5th rope being cut.

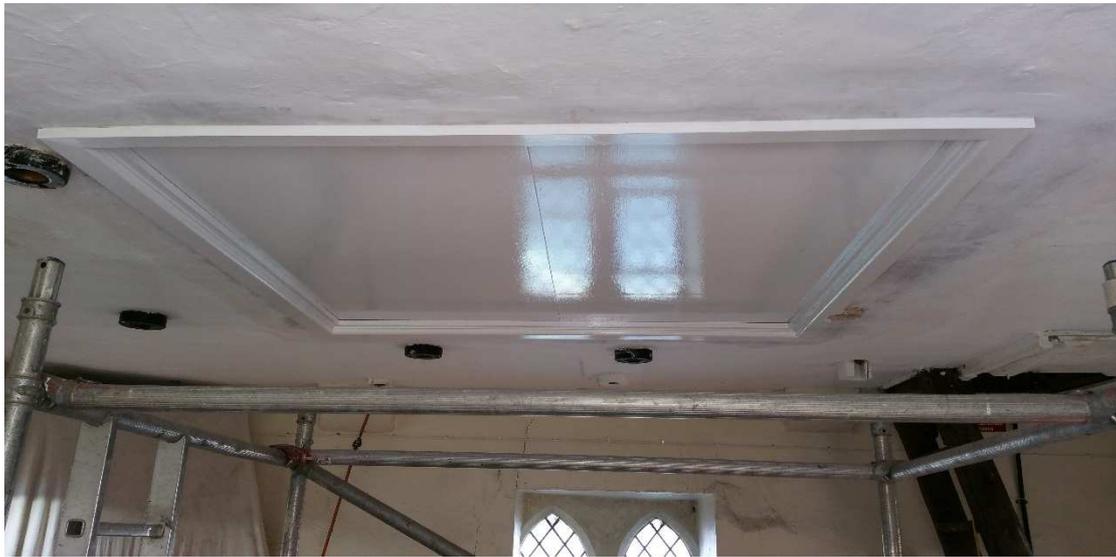
Ceiling panels fitted

Ceiling panels fitted and secured by screws. Lifting ropes fitted to the back of the ceiling panels. Insulation 200mm thick fitted. Floor panels fitted and secured with screws. First paint coat applied to ceiling and left to dry overnight. Final coat tomorrow.

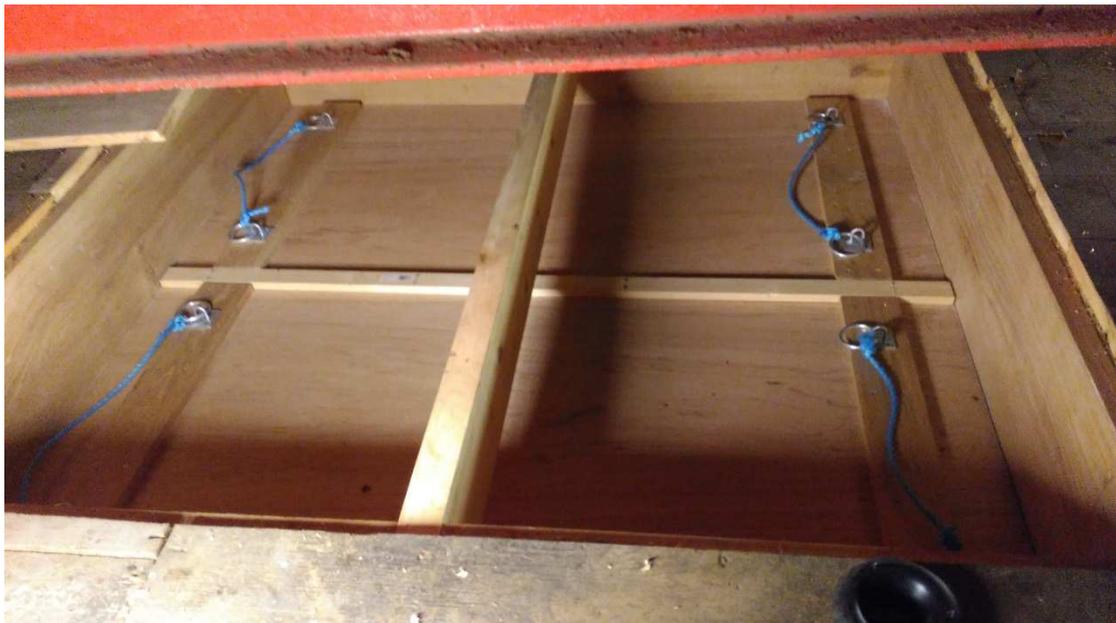
Lifting ropes fitted to back of ceiling panels

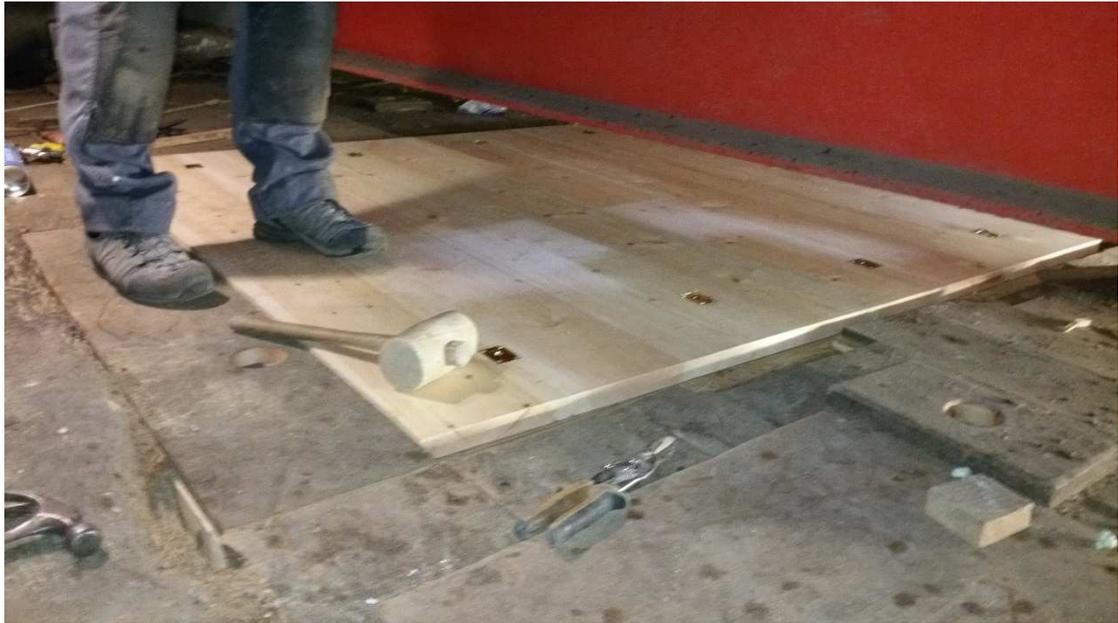
Floor panels fitted and secured with screws
