Day 1 Monday 25 February 2019

Andrew Ogden and Kit Bardsley arrived from John Taylor & Co Ltd to start the process of preparing the bellframe to accept the new headstocks and bearings of the 8 refurbished and restored bells when they return on Wednesday.

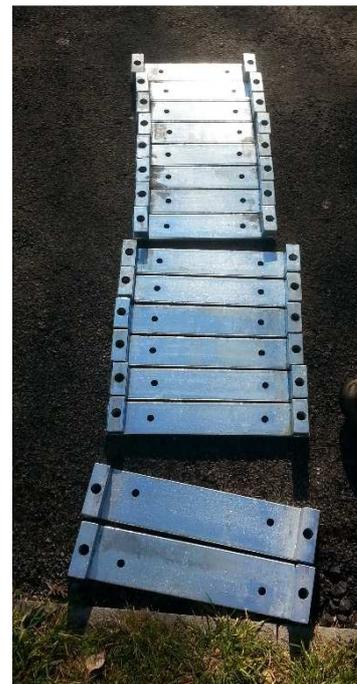
The picture opposite shows the 16 new bearing plates which have to be set into the top of the bellframe. These will need to be accurately positioned and plumbed level within each bell pit. The treble, 2nd, 3rd & 4th plates are in the background 5th 6th and 7th are the next group and the 2 tenor plates are in the foreground. There are 2 bearing plates for each bell.

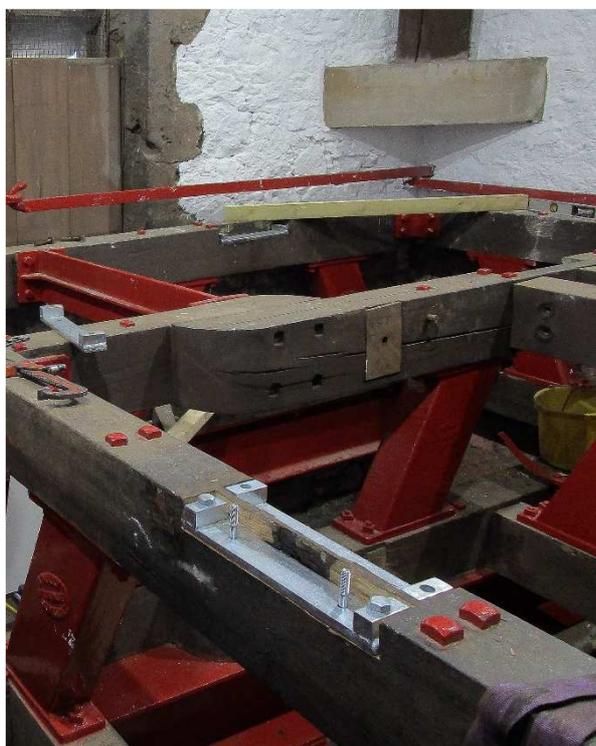
The picture opposite shows the bearing plates of the 6th (L) and 5th (R) in situ. The 6th having been accurately set into the oak sill and plumbed level across the pit. In this picture the 5th West frame has yet to be relocated back into its correct position. The bearing plate on that side will then be set level with the bearing plate shown in the picture.

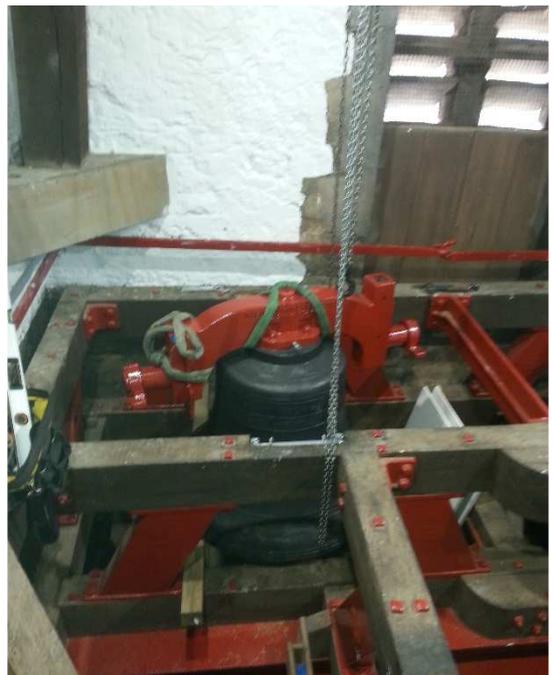
A major problem ensued. The headstock of the 7th was found to be too big for its pit.
Nothing for it but to remove the headstock and send it back to Loughborough for machining

7th in its pit but the headstock is too big

The 7th headstock was unbolted and removed from the bell and lowered into the church. It was sent back to Loughborough for urgent adjustment.

The machined 7th headstock was returned this morning. It was immediately hoisted up into the belfry. This was then securely attached to the bell and bolted down.

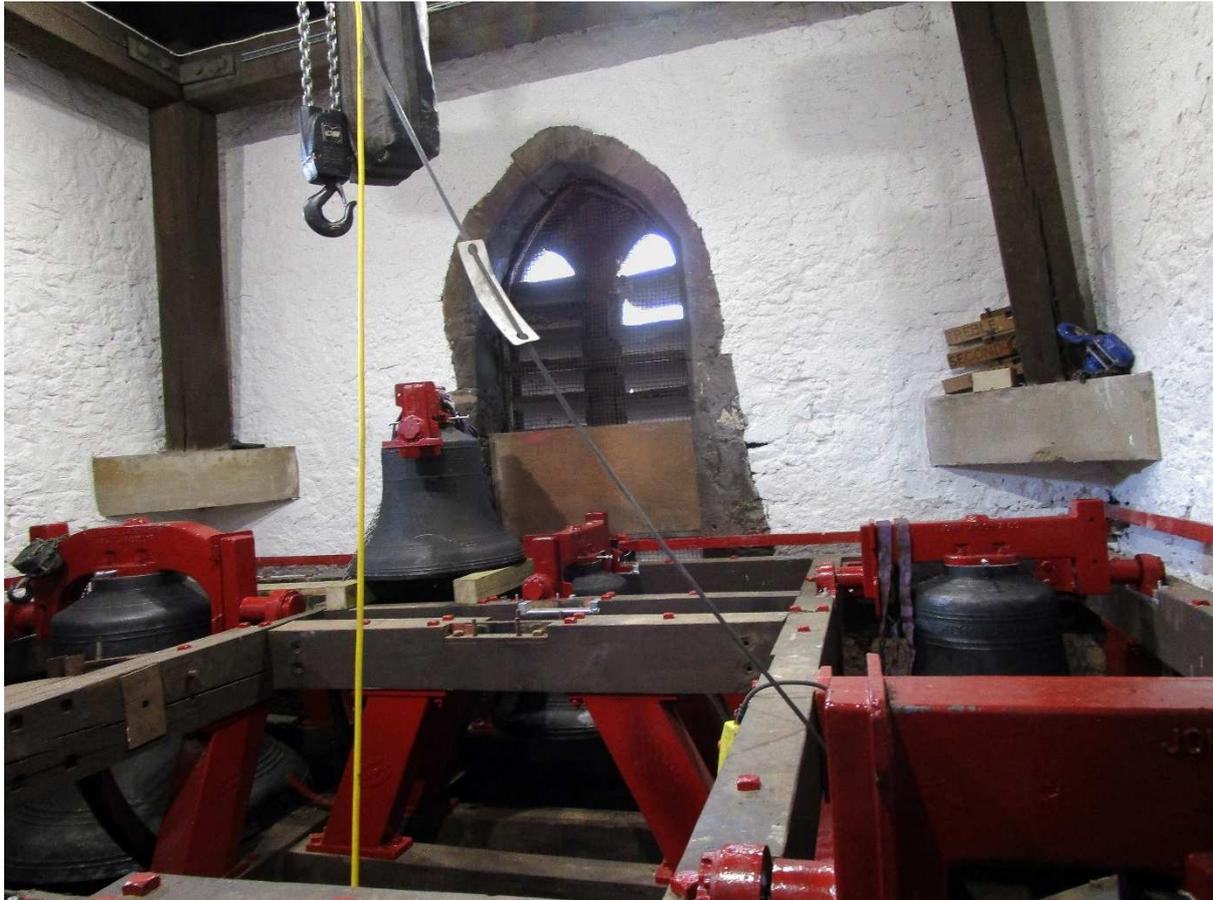
The Treble is seen sitting above the 2nds pit . The Tenor far left resting quietly whilst the 3rd & 4th nearest are doing the same

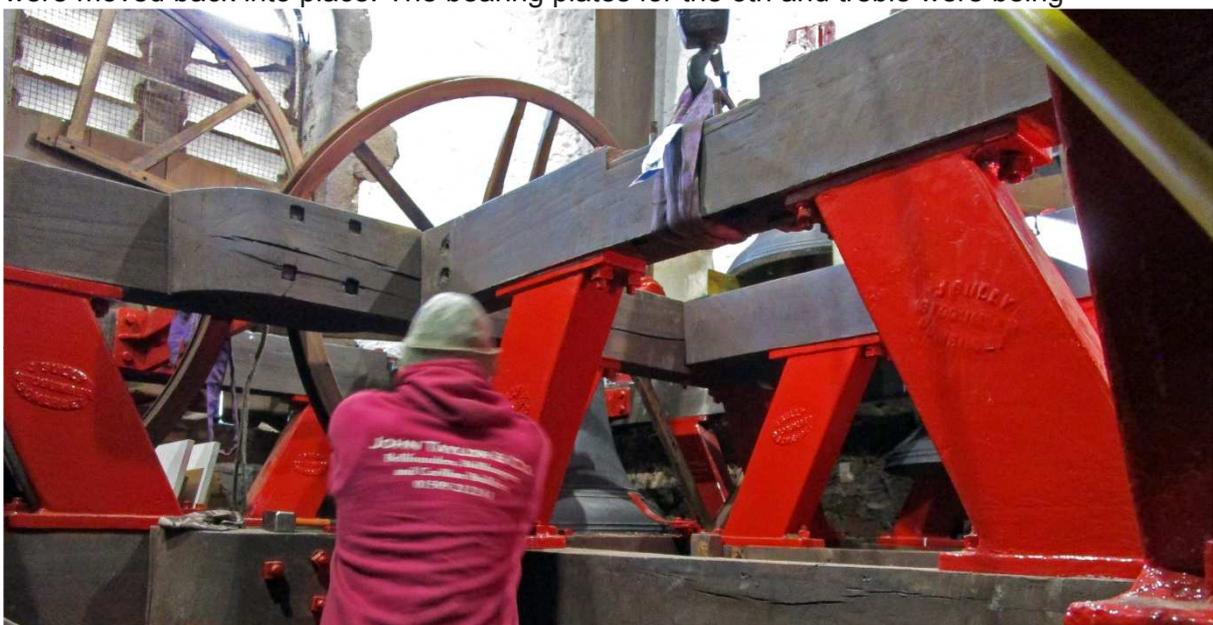
The frame between the Treble & 5th being lowered back into its place.

Progress was steady. The cut RSJ and the frame between the treble and 5th were moved back into place. The bearing plates for the 5th and treble were being

positioned in the upper sill but the work was not finished. Stays for the tenor, 7th, 3rd and 4th were in place. The wheels of the tenor and 3rd were fitted.

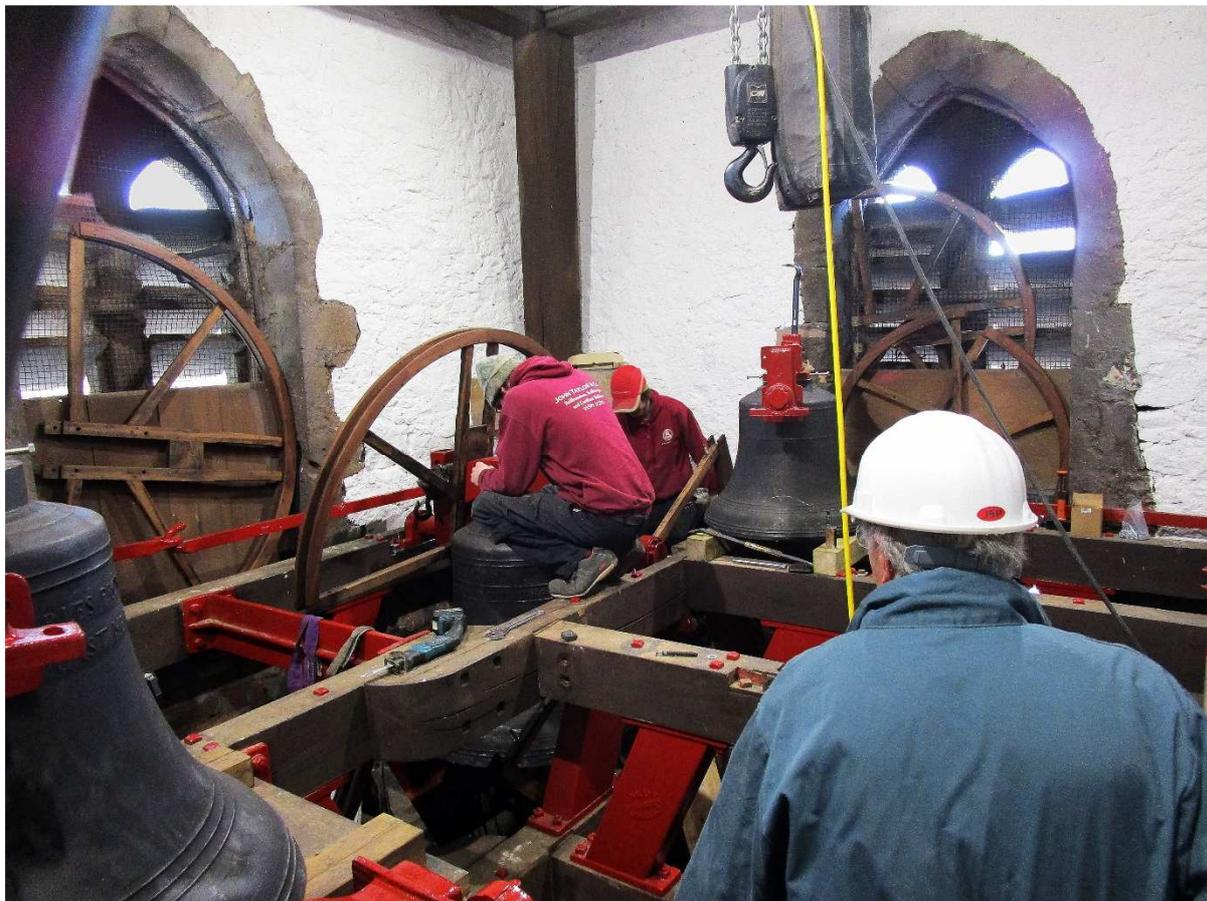
Wheel of the Tenor being fitted

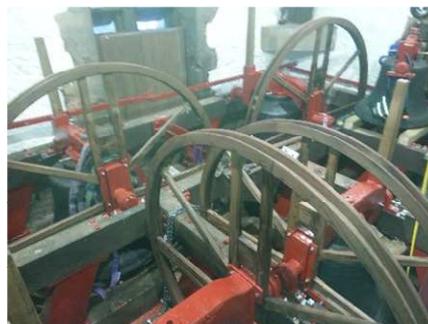
Wheels and stays on and fixed

The new wheels are much larger than before consequently the 6th bearings had to be moved 25mm South as the wheel was hitting the frame bracket nuts in the north of the pit. Some of the original oak frame bracket bolts have rusted and could not be removed from the oak timbers. Proving very difficult to replace with new thus slowing our work. Progress has been made in spite of these setbacks. The larger wheels should make ringing especially the heavy bells a bit easier. Wheels for the tenor, 7th, 6th, 5th and 3rd were on and fixed. Stays for the Tenor, 7th, 6th, 5th and 3rd were on and fixed.

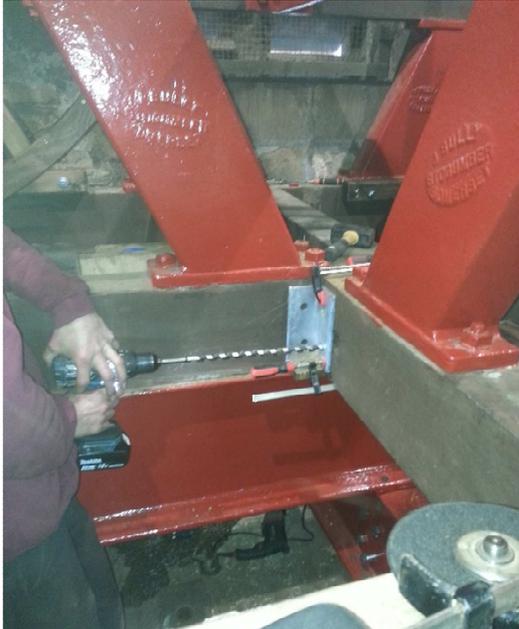
Drilling bottom sill for bracket fixings

Sliders and runners have been fixed to the 3rd, 4th and 5th. The 3rd and 4th have been wound up to test the slider stops. Extra brackets have been fixed to the frame to make sure that it is rigid especially between the treble and 5th. The 5th will be wound up tomorrow to test the slider stops. The slider stop positions are very important as these determine if the bell is deep set or correctly set. If the bell is deep set it is difficult to pull off at hand stroke.

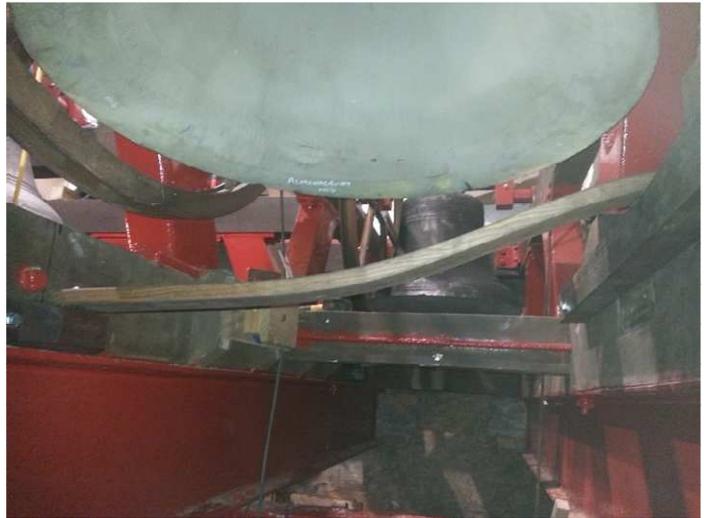
Slider and runner with stops fitted

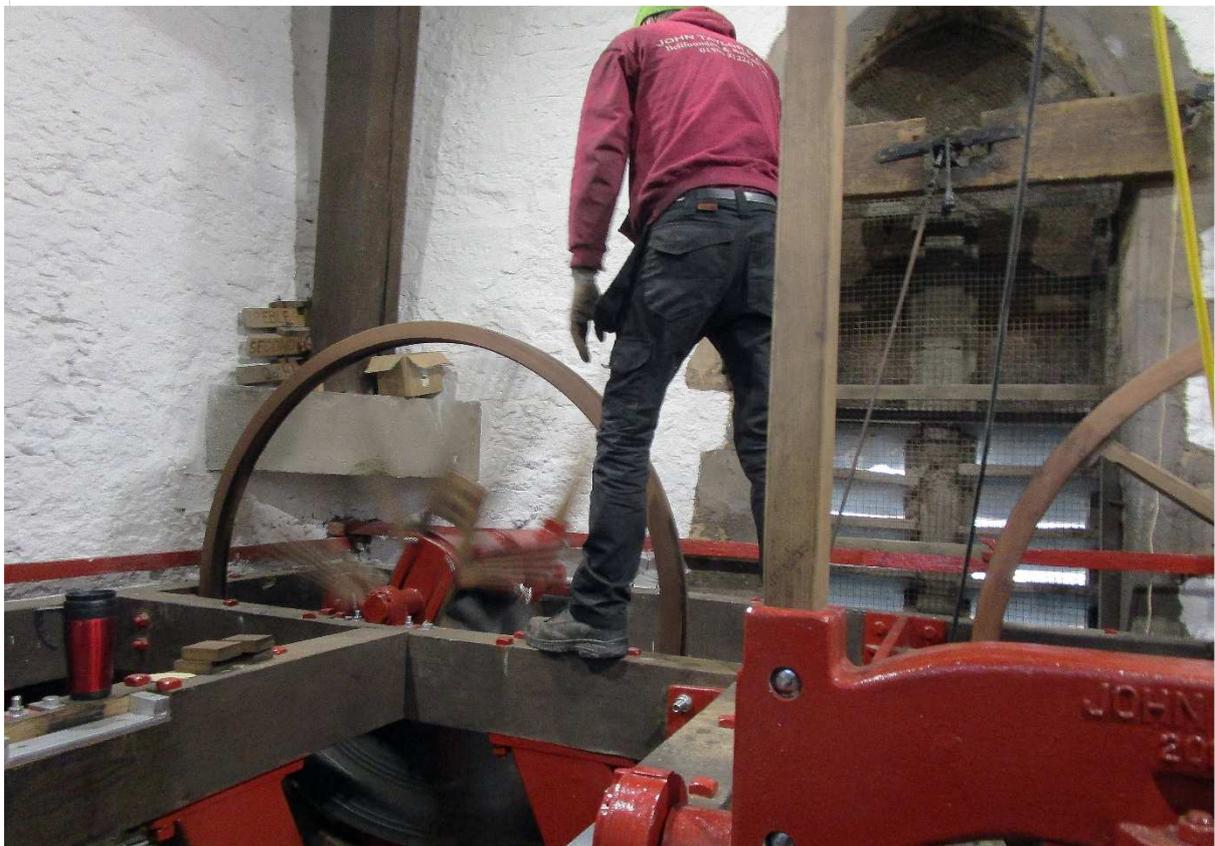
3rd being wound up to test for obstructions and correct slider positioning

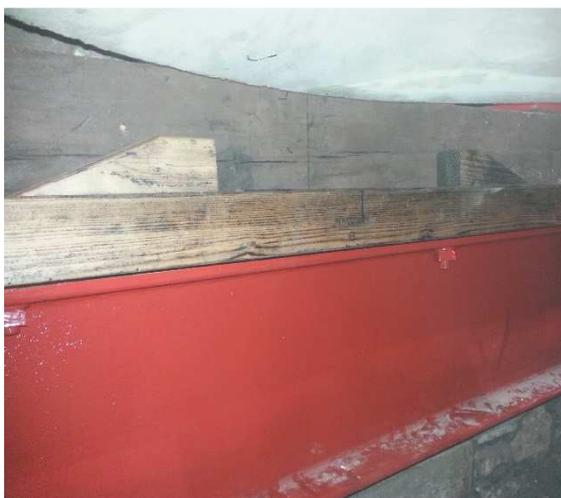
Tenor runner board with stops

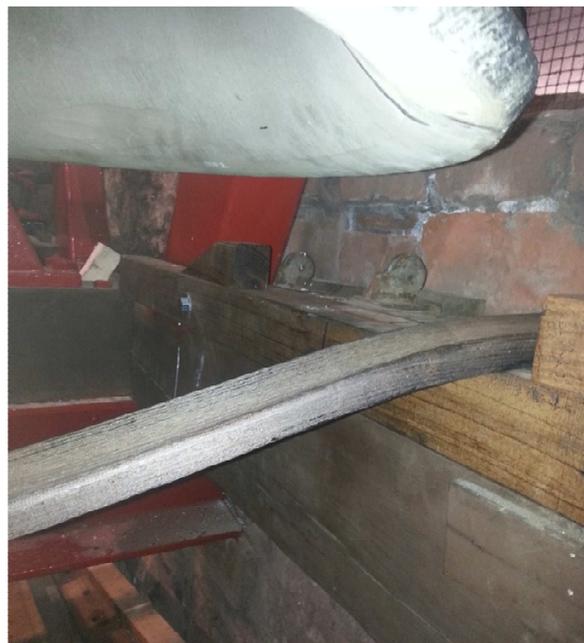
Slider with runner and stops

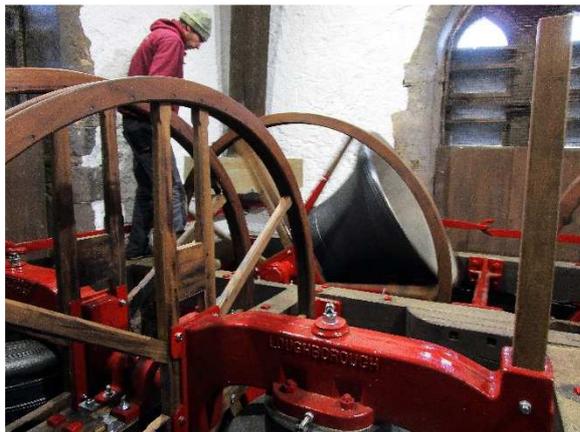
Good progress in spite of setbacks. Adjustments had to be made to the 7th and Tenor because the stay on the 7th was not clearing the concrete corbel which supports the spire timber columns and the lip of the tenor was fouling the slider. All clappers have been fitted and all bells wound up and tested. Ringing room floor hatch large joists and lower floor have been fitted. Aiming to make test ring tomorrow evening before final adjustments on Friday

Testing the 7th for clearance and runner stop settings

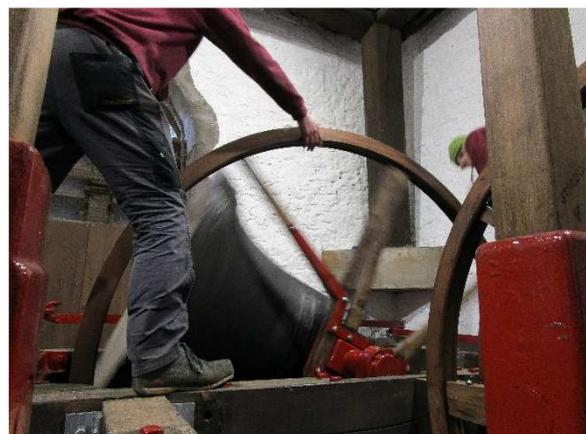
Running up the Tenor to check clearance and runner stop settings

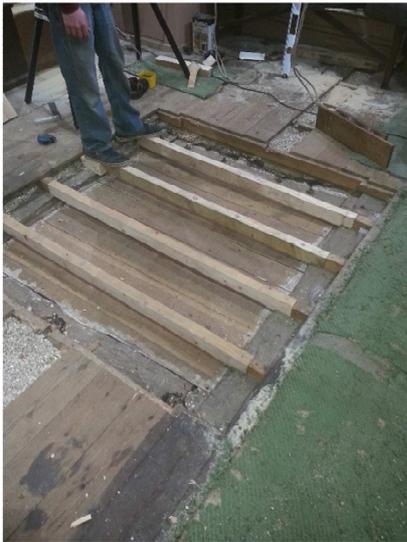
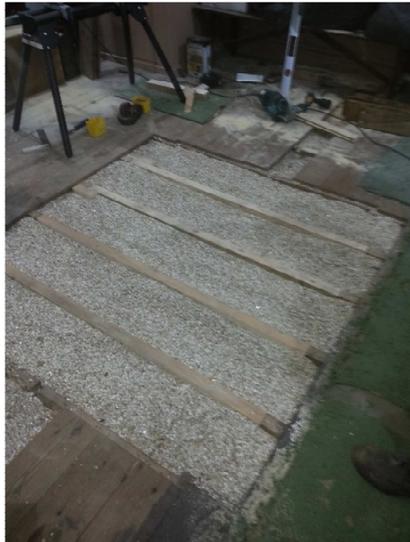
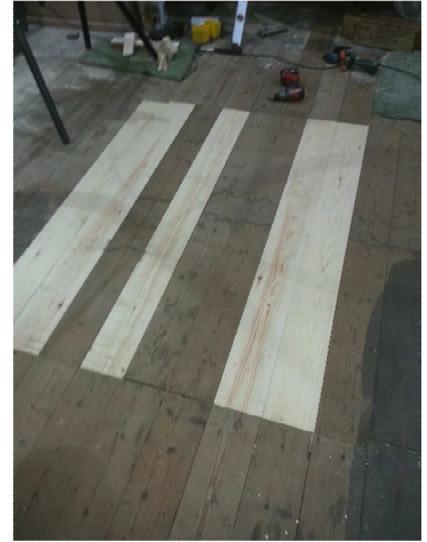
Pictures show various stages of refitting the ringing room floor over the old 1903 hatch

All ropes fitted and each bell rung up and tested. The ringing room floor hatch is fitted with new joists. New boards have been fitted to the floor hatch and the floor finally closed. Test ring carried out on all 8 bells.
